## 41 Year-Old Male Dies after Being Struck in the Head with an Auger

**Incident Number:** 02KY127  
**Date of Incident:** October 23, 2002  
**Report Release Date:** June 17, 2003

## **Kentucky Fatality Assessment & Control Evaluation (FACE) Program**

**Incident: 02KY127**

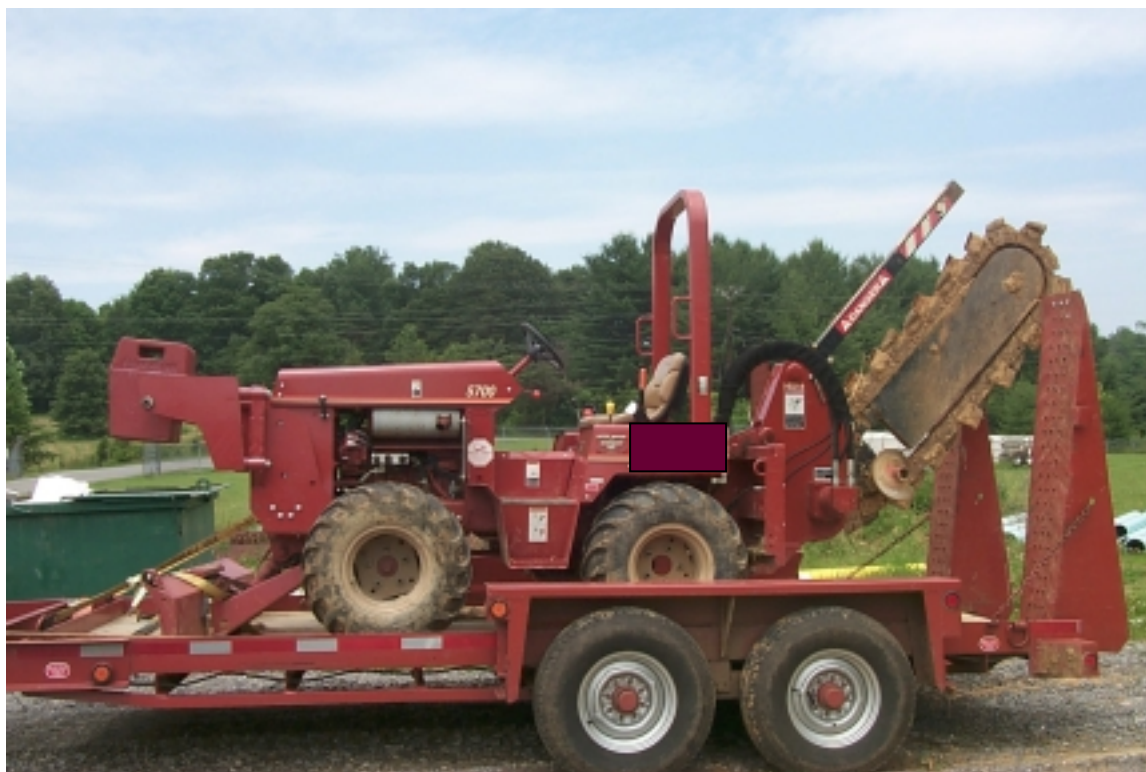
On October 23, 2002, a 41 year-old male (decedent) died after he was hit in the head with the handle of an auger. He was part of a four-member work crew tying water lines of private residences into a municipal water line. He was injured while backing the auger out of the hole and the handle became tangled with the rotating auger bit which caused the handle to flip up and strike him in the head, twice. After being struck, with co-workers following him trying to convince him to sit down, he walked away from the site until emergency rescue workers arrived and convinced him to sit down on a stretcher. He was transported to a local hospital then air lifted to a larger facility where he died five days later from a closed head injury.

The auger was powered by a tractor like device. It requires an operator in the cab controlling the off / on switch and an operator on the ground guiding the auger bit. When the auger is moving forward, away from the operator, it can be guided by a handle. If the direction of the auger bit needs to be reversed, the handle must be removed before it begins reverse direction.

- Employees should practice safe operating procedures when using dangerous equipment.
- Equipment manufacturers should re-evaluate the design of the handle to direct auger bits and research the possibility of a new design.

Note: As of the writing of this report, the handle design has been redesigned by the manufacturer to break away if the bit and rod become uncontrollable. The handles are being replaced free of charge to customers.
